U.S. Department of Energy Historic Preservation Worksheet Applicable in the Following Circumstances:

#1 NEPA Control Number from NEPA		GFO-WAP-ALRD-2023A			
determination (See Award documents):					
#2 Energy	#3 Street Address:	#4 City:	#5 County:	#6 State:	#7 Zip Code:
Auditor:					
Larry Smith	8333 Colony Ave	Pinedale	Navajo	Navajo Nation	85934
			County	(AZ)	
#8 Name of	#9 Name of THPO,	#10 Contact info. for		#11 Name of	#12 Contact
Tribe, if	if applicable	THPO, if applicable		Tribal	info. for Tribal
applicable				Representative,	Representative,
				if applicable	if applicable
Navajo Nation	Richard Jones	929-871-7198	ext. 7138	Enter name	Click here to
		PO Box 4950	Window		enter text.
		Rock, AZ 865	15

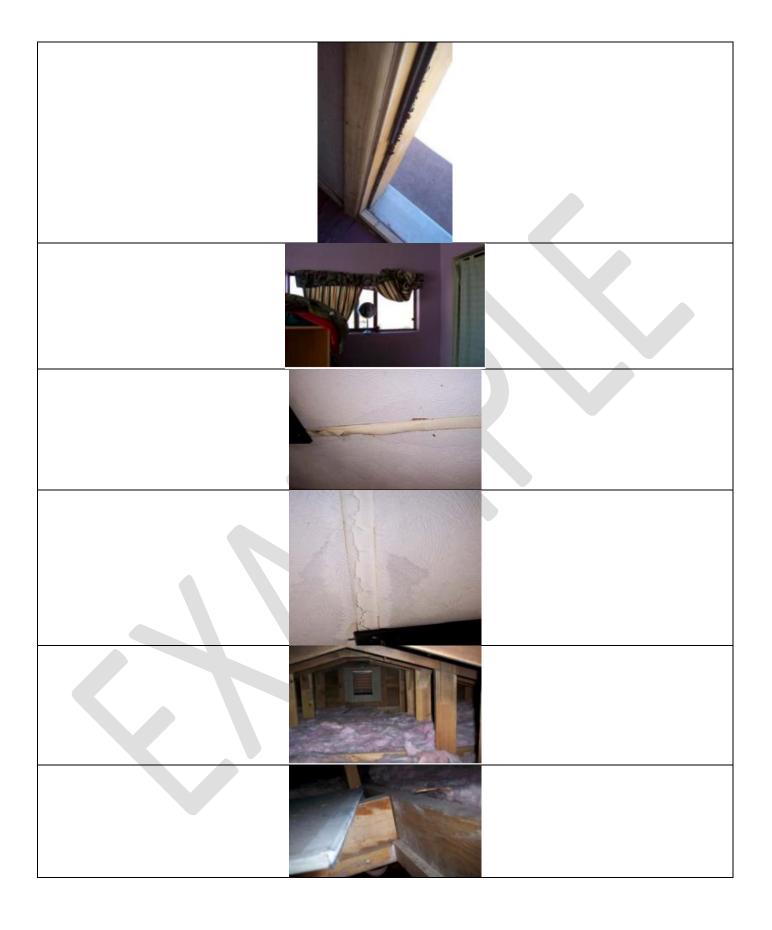
#19 Photo(s) of the exterior of the home and/or area for ground disturbance, as applicable from all viewpoints (front, back, and sides). Place photos in cells below (to insert a photo, click on the icon within the photo box). #20 Photo(s) of the interior of the home, in rooms where weatherization activities would occur, as applicable. Place photos in cells below (to insert a photo, click on the icon within the photo box).
